**Flood Control Project Maintenance
Levee Inspections**
LMA District Cover Sheet
Spring 2020 Levee Inspection Results

City of Sacramento

Spring 2020 Levee Inspection Results

Waterway			Bank	Unit Miles
Unit No. 01 Sacramento River			Left	3.67
	Spring (March - May)	Summer (June - August)	(September - November) Fall	Winter (December - February)
Unit Maintenance Rating (Fall Only)				
Date of Inspection	3/18/2020 - 3/18/2020			
DWR Inspector	Luz Dial			
Accompanied By

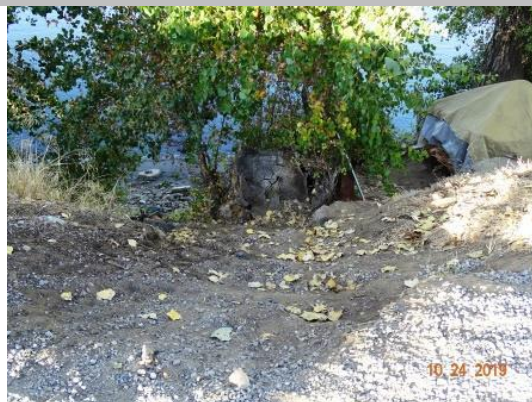
Photo 1 of 2 : SP_2020_NA0005_251_73_20200302_00010.jpg

LM Start	0.02	Rating **	A/W	Issue No.	73
LM End	0.02	Issue Type +	Ma	Location *	WS
Category	Earthen Levee			GPS Latitude/Longitude	
				Start	End
Item	Slope Stability			38.590427 °	38.590427 °
				-121.505233 °	-121.505233 °
DWR ID	DWR_NA0005_01_f_2019_73				
Comment Code					
S2 : Repair the levee slope damaged by foot traffic and prevent access where possible.					
Inspector Comment					
Monitor footpaths.

View of one of two footpaths on the waterside slope. Fall 2019

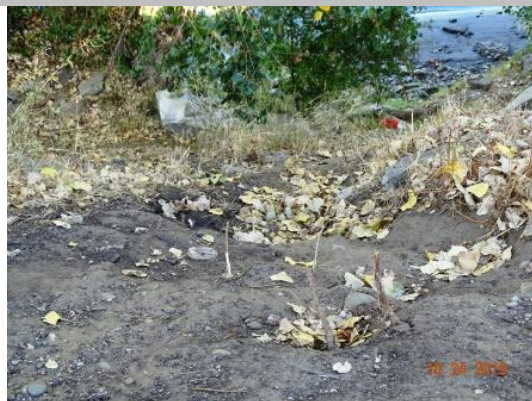
Photo 2 of 2 : SP_2020_NA0005_251_73_20200302_00011.jpg

View of one of two footpaths on the waterside slope. Fall 2019

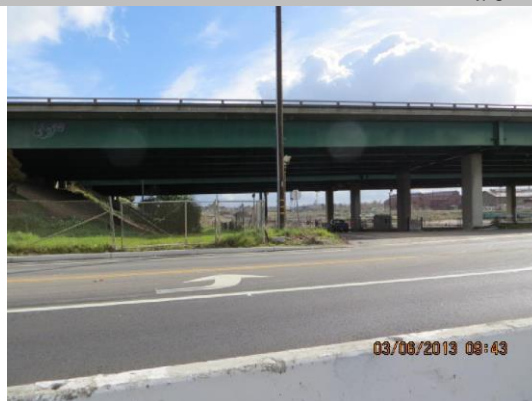
Photo 1 of 3 : UCIP_SP_2020_49955_33806.jpg

View of levee crown at crossing--sign visible on landward side near freeway underpass.

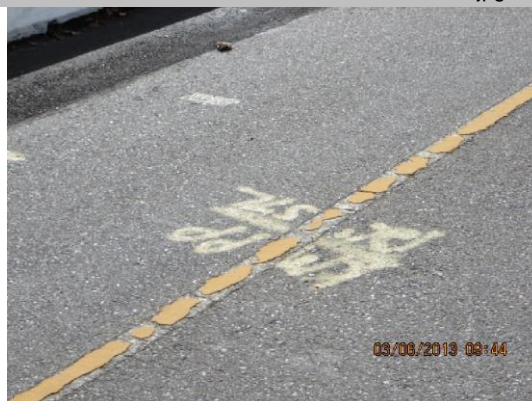
Photo 3 of 3 : UCIP_SP_2020_49955_33807.jpg

Underground service alert (USA) markings indicate 12 inch crossing through levee.

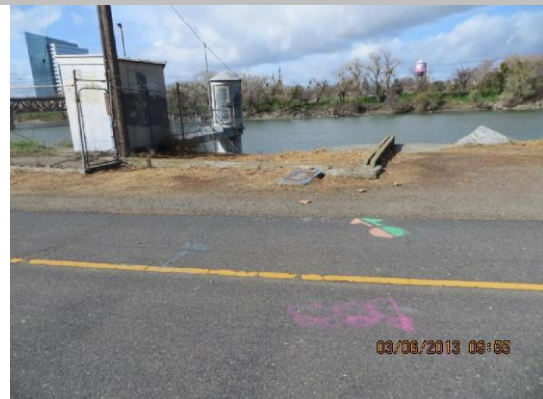
Photo 2 of 3 : UCIP_SP_2020_41414_72621.jpg

Underground Service Alert (USA) markings indicating 42 inch line through levee.

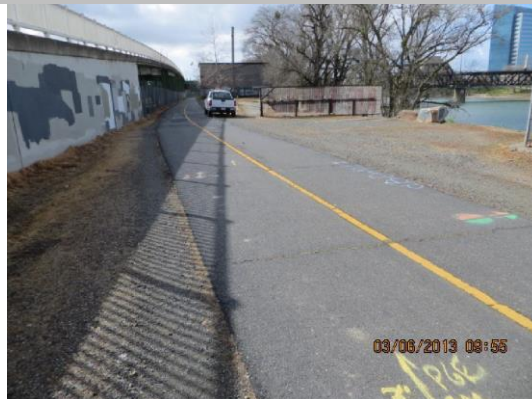
Photo 1 of 3 : UCIP_SP_2020_52599_72627.jpg

View of levee crown and alignment of PG&E line visible by yellow paint markings.

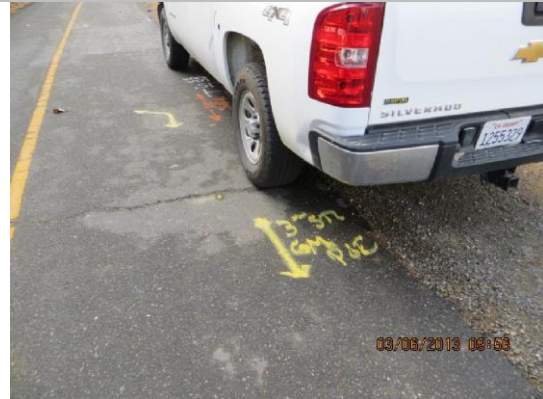
Photo 2 of 3 : UCIP_SP_2020_52599_72626.jpg

Underground Service Alert (USA) markings of PG&E line through levee,
Photo 1 of 2.

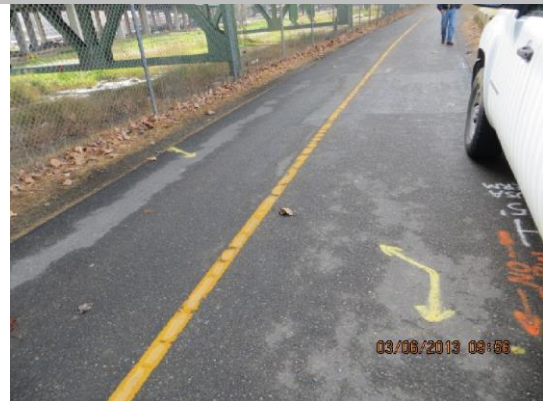
Photo 3 of 3 : UCIP_SP_2020_52599_72625.jpg

Underground Service Alert (USA) markings of PG&E line through levee,
Photo 2 of 2.

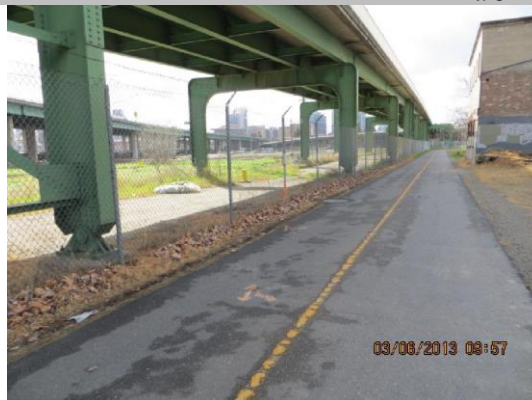
Photo 2 of 2 : UCIP_SP_2020_41416_72628.jpg

Alignment of communication line through levee, Photo 2 of 2.

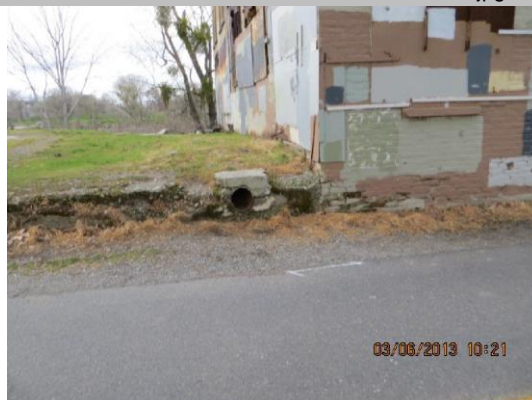
Photo 1 of 3 : UCIP_SP_2020_40848_72633.jpg

Pipe through levee visible next to building located on levee.

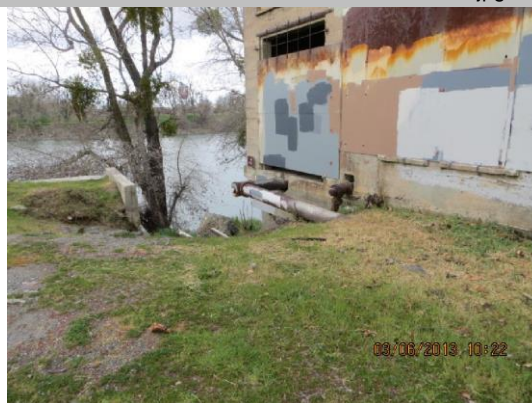
Photo 3 of 3 : UCIP_SP_2020_40848_72631.jpg

View of building and additional concrete structures located on levee crown at waterward side.

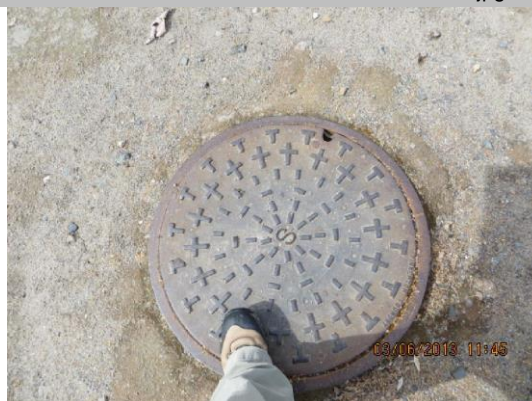
Photo 2 of 3 : UCIP_SP_2020_20384_34409.jpg

View of manhole located at the edge of waterward.

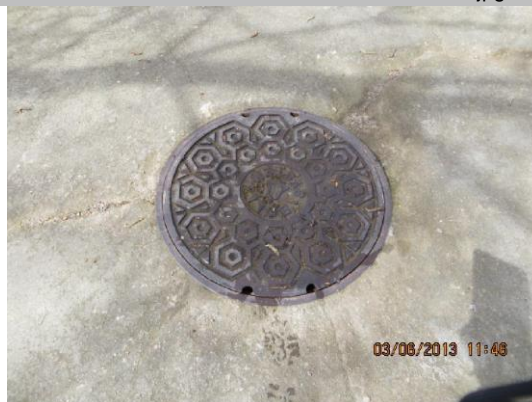
Photo 1 of 3 : UCIP_SP_2020_41417_72642.jpg

PacBell manhole located on waterward side.

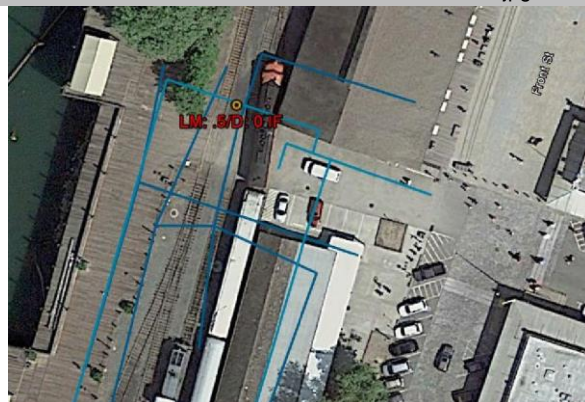
Photo 1 of 1 : UCIP_SP_2020_41418_72741.jpg

Aproximate alignment provided by City of Sacramento -- unable to confirm if crossing is active.

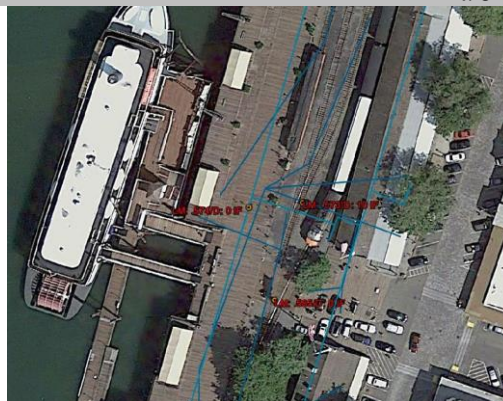
Photo 1 of 1 : UCIP_SP_2020_41419_72742.jpg

Approximate alignment provided by the City of Sacramento--unable to confirm crossing in field.

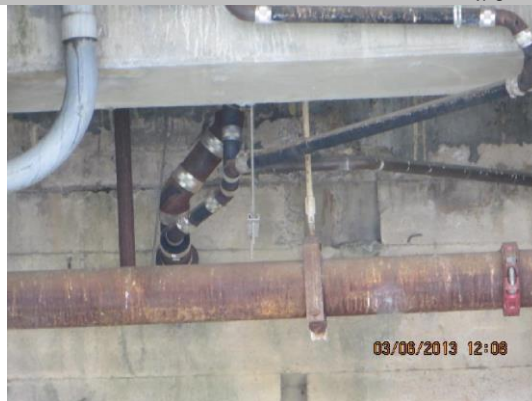
Photo 1 of 1 : UCIP_SP_2020_41260_72743.jpg

Conduit through floodwall.

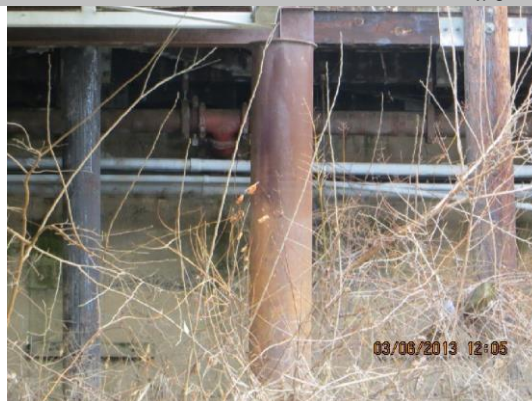
Photo 1 of 1 : UCIP_SP_2020_41263_72744.jpg

Pipe through floodwall.

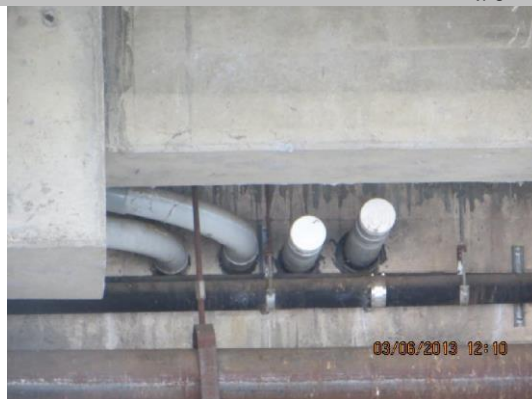
Photo 1 of 1 : UCIP_SP_2020_41420_72746.jpg

View of conduits through floodwall visible from waterward side.

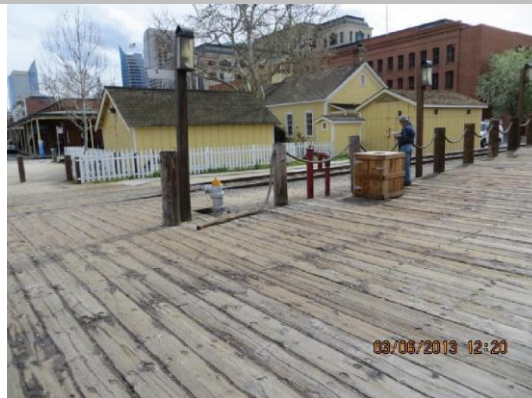
Photo 1 of 1 : UCIP_SP_2020_41266_72747.jpg

Fire hydrant visible on levee crown.

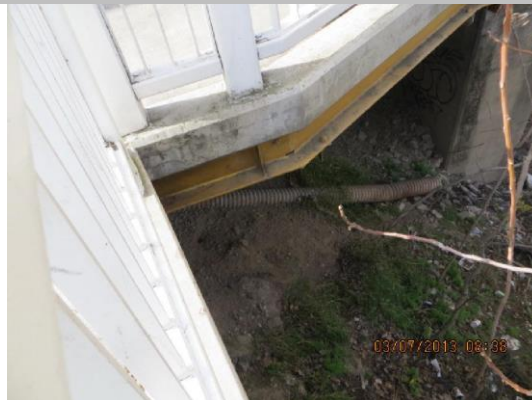
Photo 2 of 3 : UCIP_SP_2020_41421_72749.jpg

Pipe visible on waterward side.

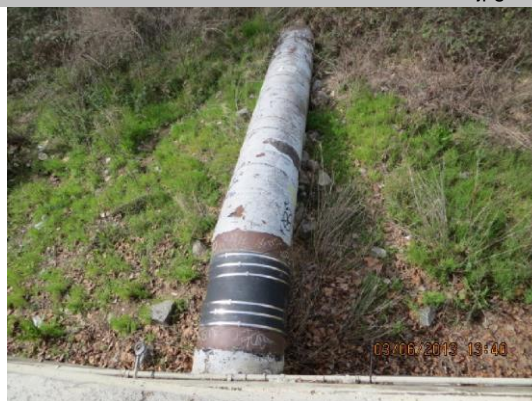
Photo 3 of 3 : UCIP_SP_2020_52601_34412.jpg

View of pipe crossing through floodwall--waterward side.

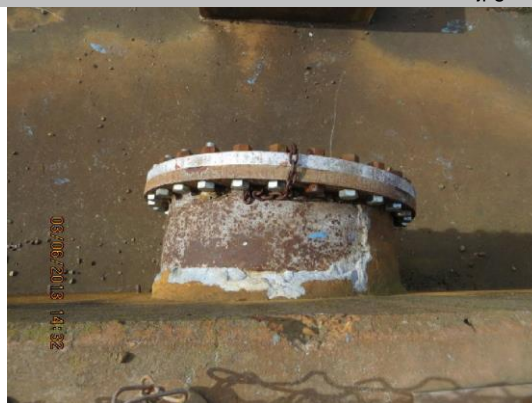
Photo 3 of 3 : UCIP_SP_2020_41425_34143.jpg

Metal plate used to cap off pipe.

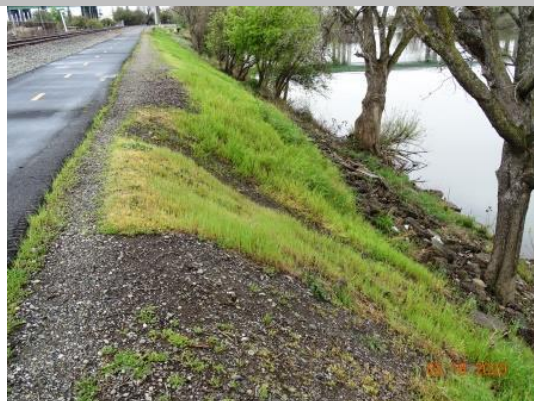
Photo 1 of 1 : SP_2020_NA0005_251_78_20200319_00121.jpg

View of footpath on the waterside slope. Spring 2020

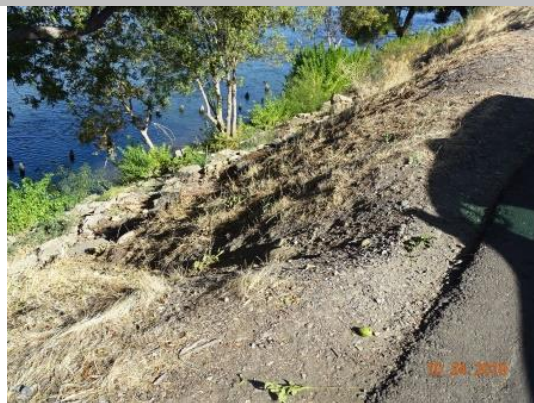
Photo 1 of 3 : SP_2020_NA0005_251_72_20200302_00007.jpg

View of a footpath on the waterside slope near LM 1.31. Fall 2019

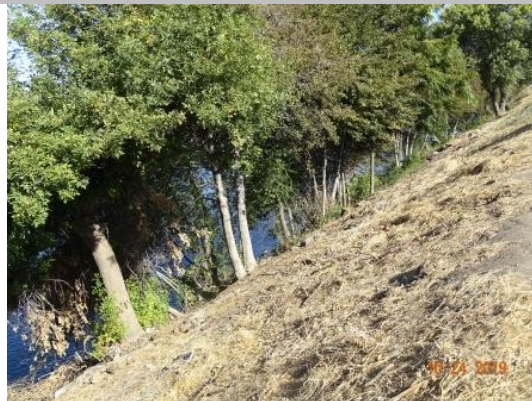
Photo 3 of 3 : SP_2020_NA0005_251_72_20200302_00009.jpg

View looking upstream at erosion site near LM 1.39. Fall 2019

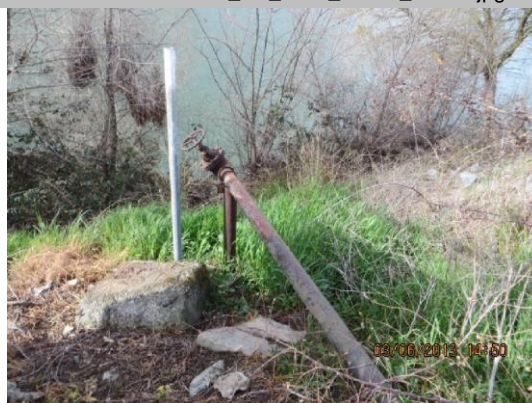
Photo 2 of 2 : UCIP_SP_2020_49767_34066.jpg

View of pipe and gate valve located on waterward slope.

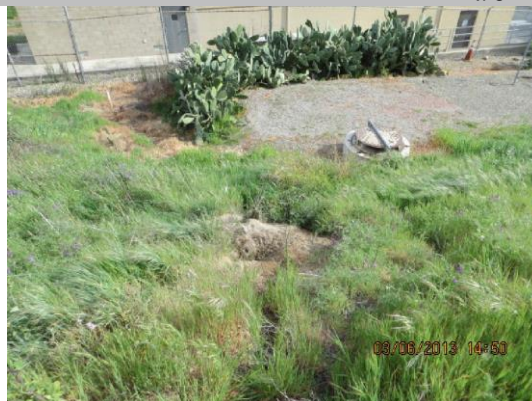
Photo 2 of 3 : UCIP_SP_2020_49957_34072.jpg

View of landward side--tall grass along slope limit inspection.

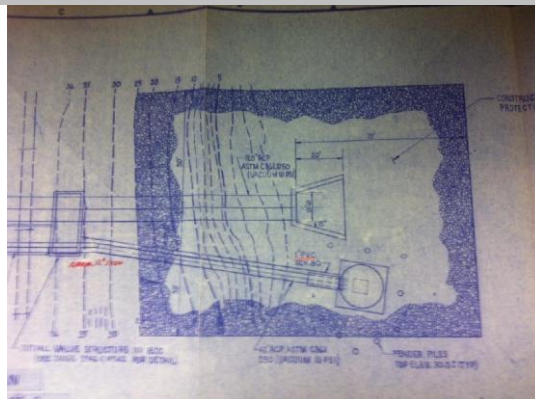
Photo 2 of 3 : UCIP_SP_2020_49778_34027.jpg

Rip rap protection around outfall structure for 42-inch and 120-inch pipes.

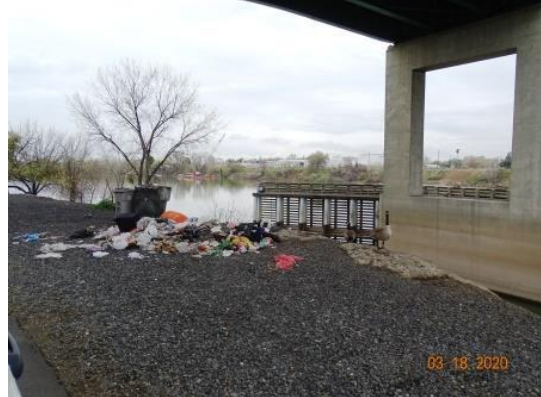
Photo 1 of 1 : SP_2020_NA0005_251_76_20200319_00119.jpg

View of garbage on the waterside shoulder. Spring 2020

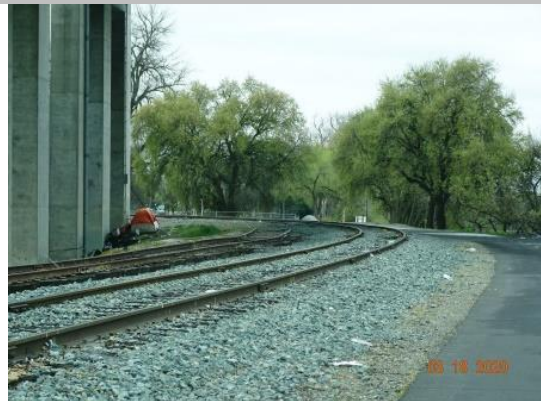
Photo 1 of 1 : SP_2020_NA0005_251_80_20200319_00123.jpg

View of camps on the landside levee toe. Spring 2020

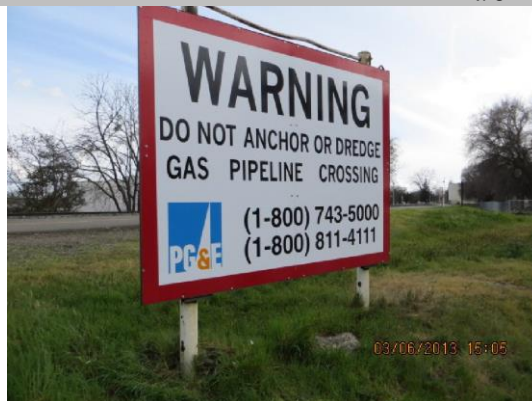
Photo 1 of 3 : UCIP_SP_2020_32883_59502.jpg

PG&E warning gas line crossing--waterward side view.

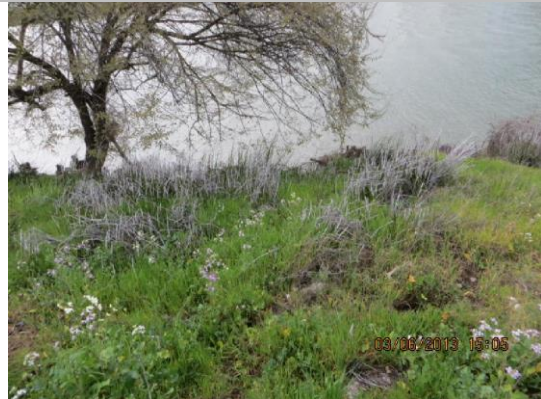
Photo 2 of 3 : UCIP_SP_2020_32883_59501.jpg

View of waterward slope--tall grass limits inspection.

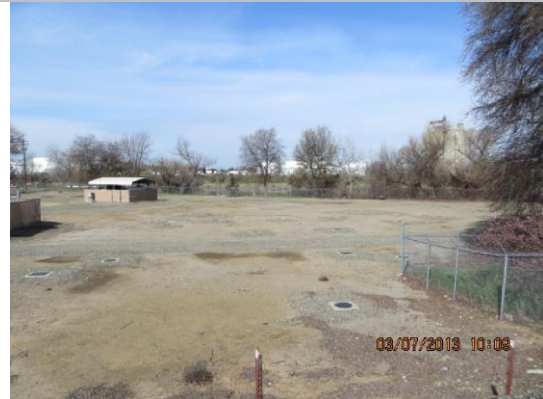
Photo 3 of 3 : UCIP_SP_2020_41282_59573.jpg

More vapor wells present on levee crown.

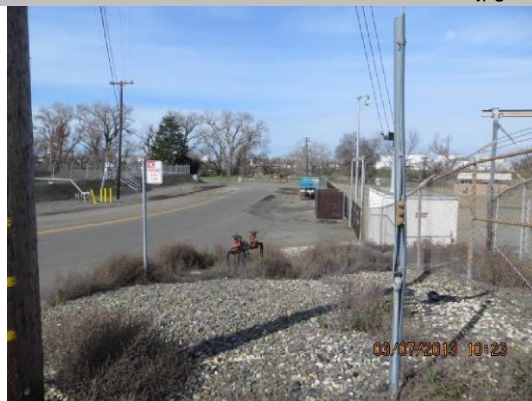
Photo 2 of 3 : UCIP_SP_2020_41427_59506.jpg

Backflow prevention device on shoulder.

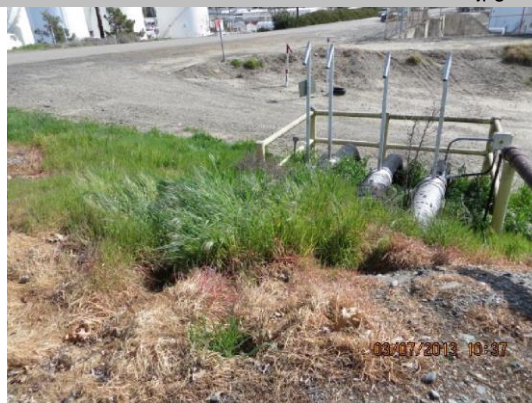
Photo 3 of 3 : UCIP_SP_2020_41448_59512.jpg

Dense vegetation and large burrow holes located on shoulder.

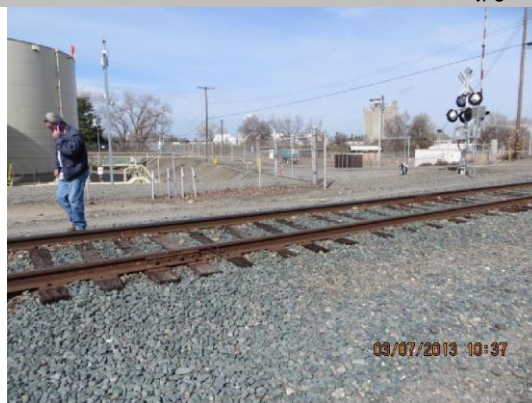
Photo 3 of 3 : UCIP_SP_2020_48322_59519.jpg

Pipe markers visible along the chain link fence on waterward side.

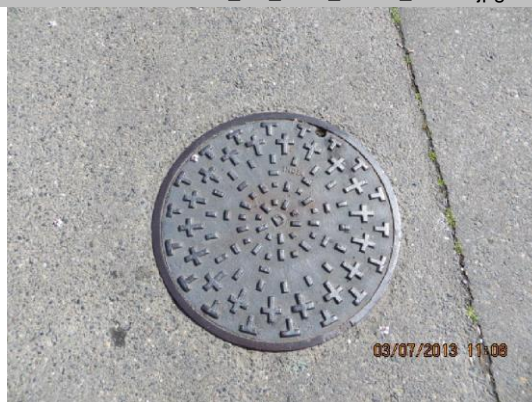
Photo 1 of 3 : UCIP_SP_2020_41430_72757.jpg

Manhole present on roadway.

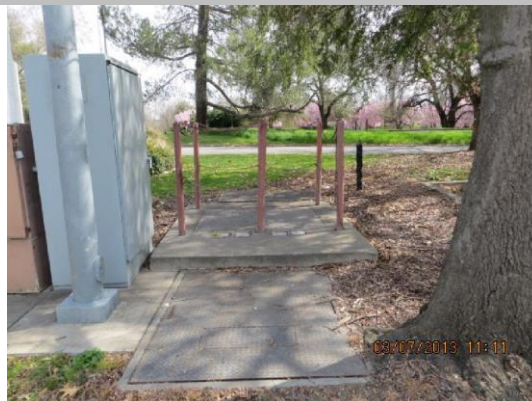
Photo 3 of 3 : UCIP_SP_2020_41430_72755.jpg

Service vault visible on levee crown.

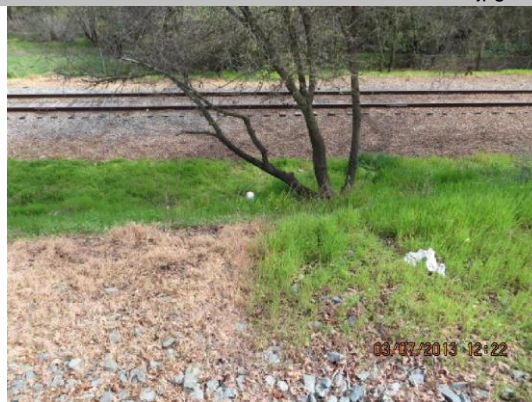
Photo 1 of 2 : UCIP_SP_2020_41293_72760.jpg

PVC pipe through levee.

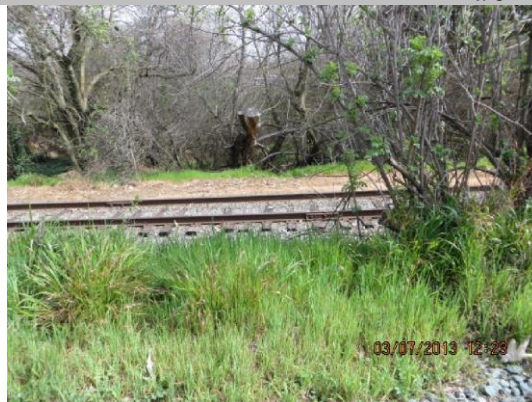
Photo 2 of 2 : UCIP_SP_2020_38827_72765.jpg

Dense vegetation on landward side.

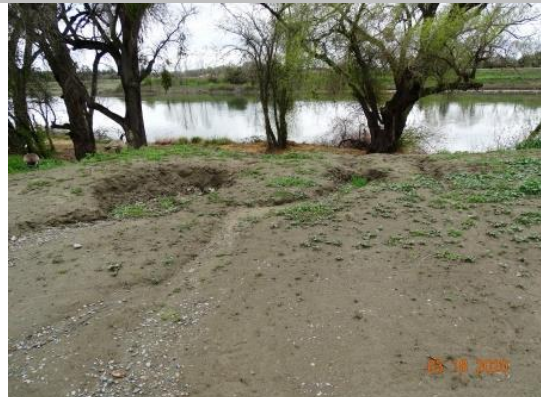
Photo 1 of 2 : SP_2020_NA0005_251_88_20200319_00126.jpg

View of large holes on the waterside shoulder. Spring 2020
